Cross-Band Modification

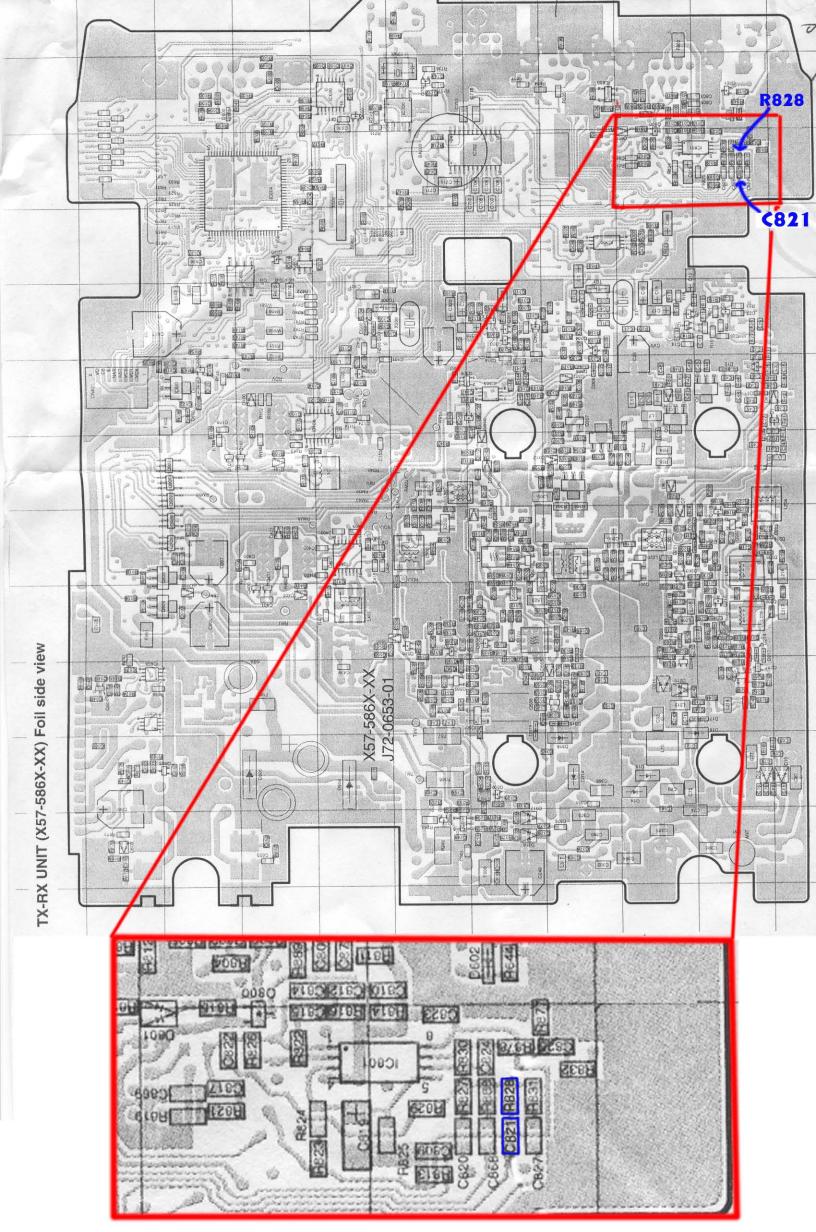
This modification will fix the over deviated/muffled transmitted audio while using the Cross-Band Repeater

Change C821 to 0.022uF Change R828 to 22K
